**Flood Control Project Maintenance  
Levee Inspections**

**2010 Channel Summary Report**

**San Joaquin County Flood Control and Water Conservation District**

**Flood Control Project Maintenance****Unit Cover Sheet****2010 Channel Inspection Results****San Joaquin County Flood Control and Water Conservation District**

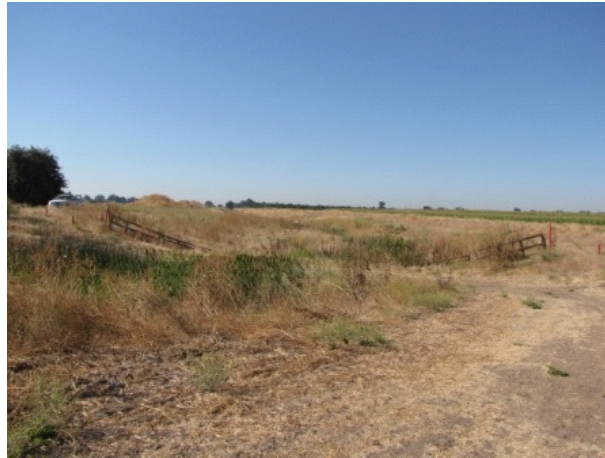
dpesaven\_c\_20100824\_012.jpg

View looking downstream from the Duck Creek Diversion Structure.

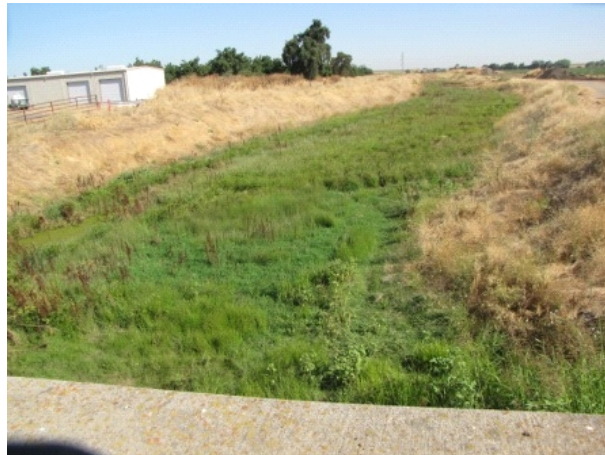
dpesaven\_c\_20100824\_013.jpg

View looking upstream from the Farmington Road/Highway 4 bridge.

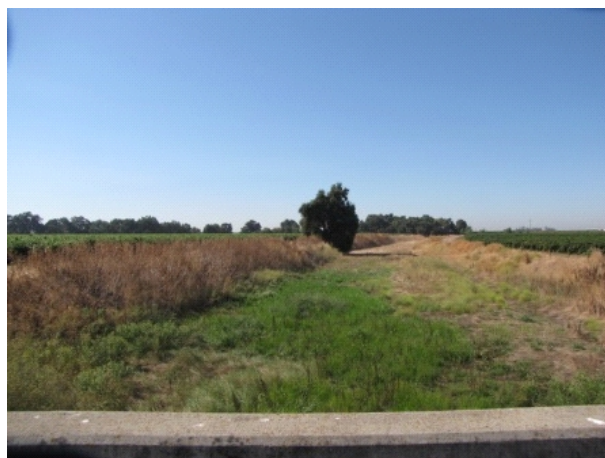
dpesaven\_c\_20100824\_014.jpg

View looking downstream from the Farmington Road/Highway 4 bridge.

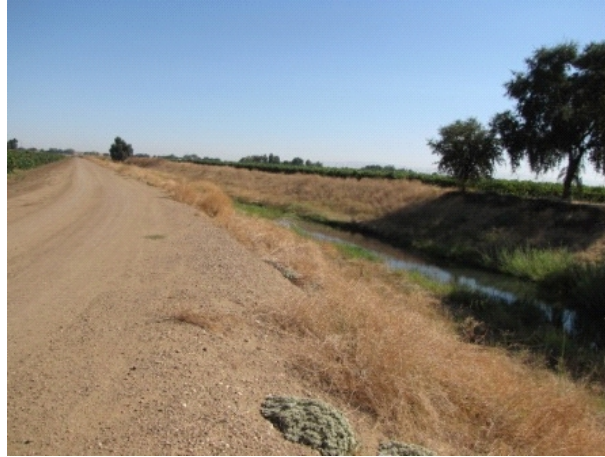
Levee Mile Report Line	16
Start Levee Mile	0.00
End Levee Mile	0.00
Location	
Category	Channels
Item	Vegetation & Obstructions
View looking upstream along the west bank from the confluence with South Little John Creek.	
dpesaven_c_20100824_015.jpg

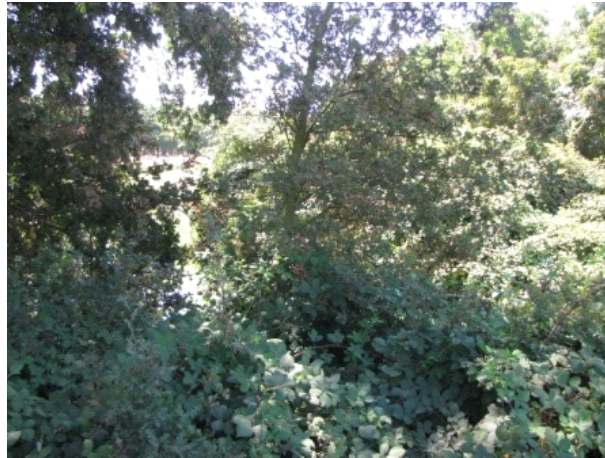
dpesaven\_c\_20100824\_016.jpg

Obstructed view of where North Little John Creek branches from South Little John Creek.

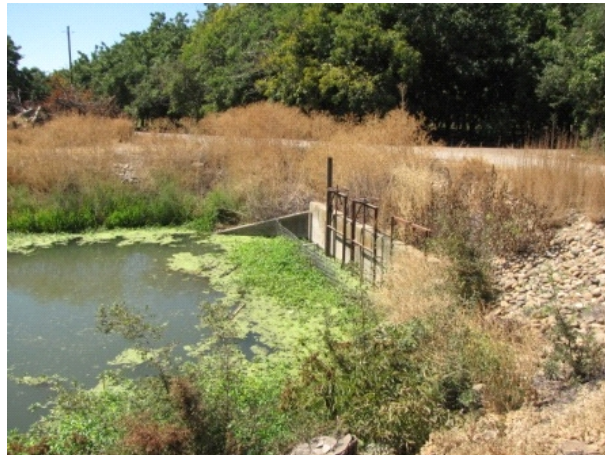
dpesaven\_c\_20100824\_017.jpg

View of the upstream side of the culverts under Hewit Lane.

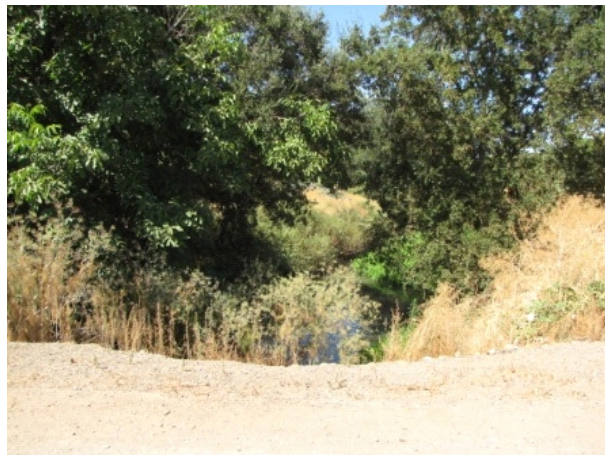
dpesaven\_c\_20100824\_018.jpg

View looking upstream from Hewit Lane.

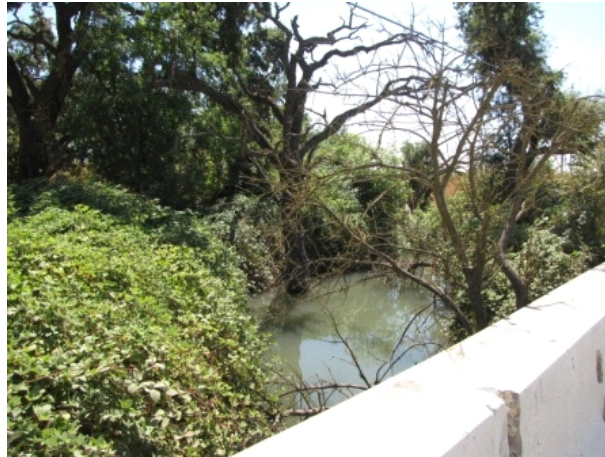
Levee Mile Report Line	16
Start Levee Mile	0.00
End Levee Mile	0.00
Location	
Category	Channels
Item	Vegetation & Obstructions
View looking upstream from the Van Allen Road bridge.	
dpesaven_c_20100824_019.jpg

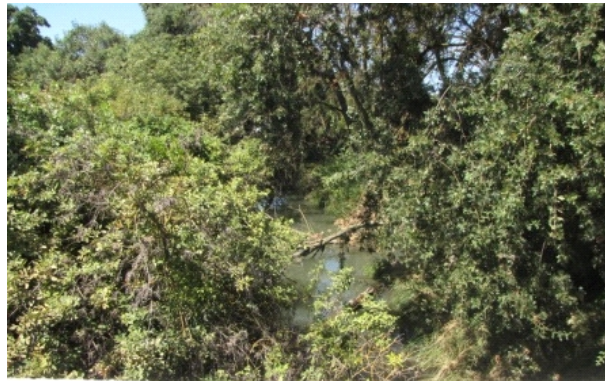
Levee Mile Report Line	21
Start Levee Mile	0.00
End Levee Mile	0.00
Location	
Category	Channels
Item	Vegetation & Obstructions
View looking downstream from the Van Allen Road bridge.	
dpesaven_c_20100824_020.jpg

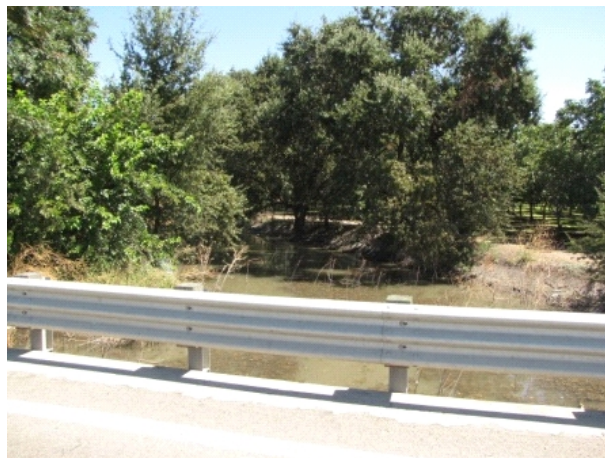
Levee Mile Report Line	26
Start Levee Mile	0.00
End Levee Mile	0.00
Location	
Category	Channels
Item	Vegetation & Obstructions
View looking upstream from the Jack Tone Road bridge.	
dpesaven_c_20100824_032.jpg

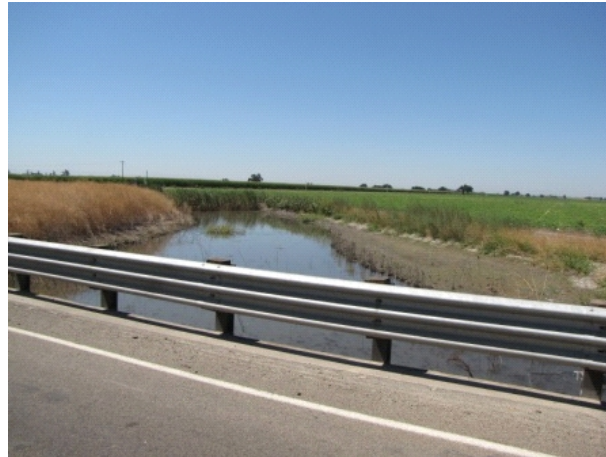
Levee Mile Report Line	31
Start Levee Mile	0.00
End Levee Mile	0.00
Location	
Category	Channels
Item	Vegetation & Obstructions
View looking downstream from the Jack Tone Road bridge.	
dpesaven_c_20100824_033.jpg

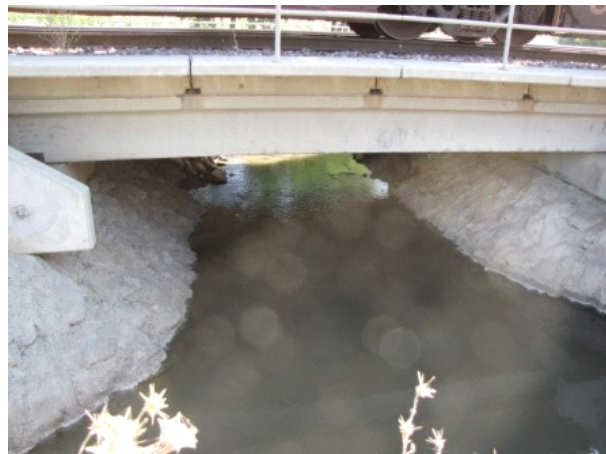
Levee Mile Report Line	36
Start Levee Mile	0.00
End Levee Mile	0.00
Location	
Category	Channels
Item	Vegetation & Obstructions
View under the rail roadbridge looking upstream from the Mariposa Road bridge.	
dpesaven_c_20100825_034.jpg

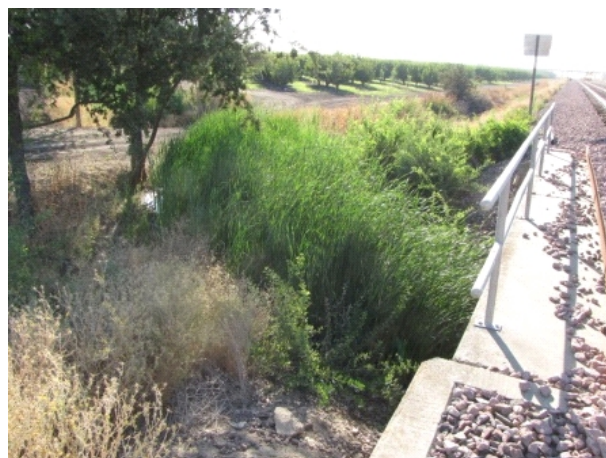
Levee Mile Report Line	36
Start Levee Mile	0.00
End Levee Mile	0.00
Location	
Category	Channels
Item	Vegetation & Obstructions
View looking upstream from the railroad bridge at Mariposa Road.	
dpesaven_c_20100825_035.jpg

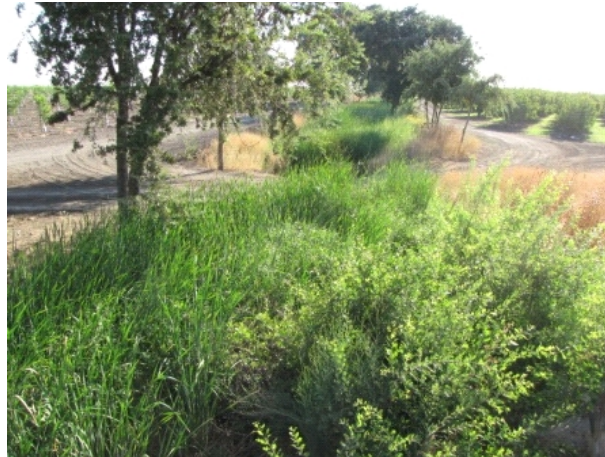
Levee Mile Report Line	36
Start Levee Mile	0.00
End Levee Mile	0.00
Location	
Category	Channels
Item	Vegetation & Obstructions
Additional view looking upstream from the railroad bridge at Mariposa Road.	
dpesaven_c_20100825_038.jpg

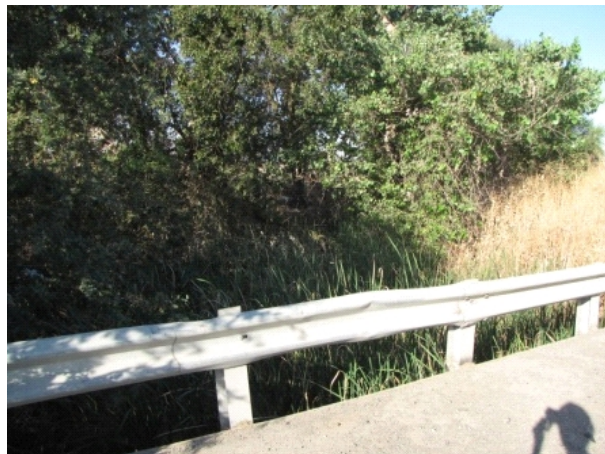
Levee Mile Report Line	41
Start Levee Mile	0.00
End Levee Mile	0.00
Location	
Category	Channels
Item	Vegetation & Obstructions
View looking downstream from the Mariposa Road bridge.	
dpesaven_c_20100825_036.jpg

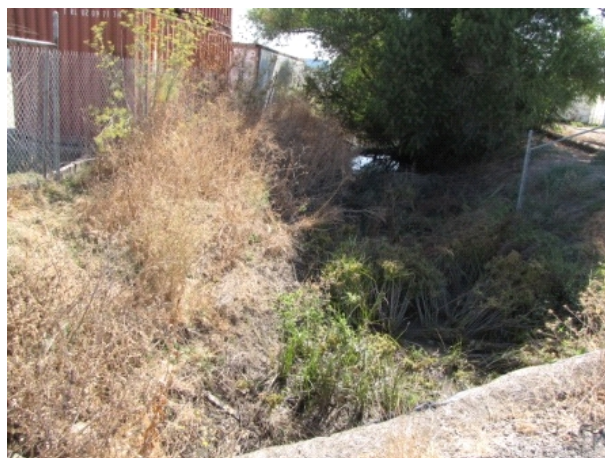
Levee Mile Report Line	46
Start Levee Mile	
End Levee Mile	
Location	
Category	Channels
Item	Vegetation & Obstructions
View looking upstream from the frontage road along Highway 99.	
dpesaven_c_20100825_045.jpg

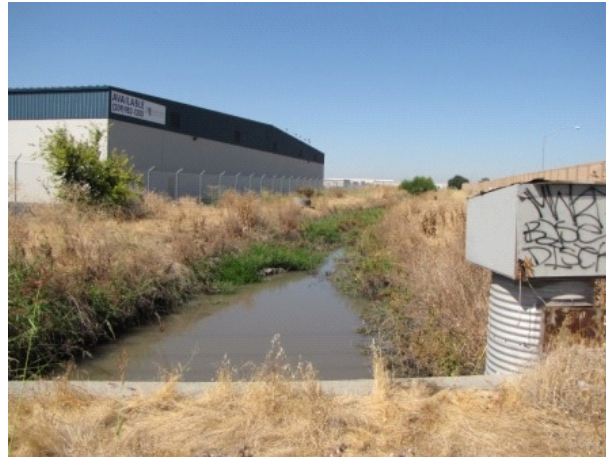
Levee Mile Report Line	51
Start Levee Mile	
End Levee Mile	
Location	
Category	Channels
Item	Vegetation & Obstructions
View looking downstream from the frontage road along Highway 99.	
dpesaven_c_20100825_046.jpg

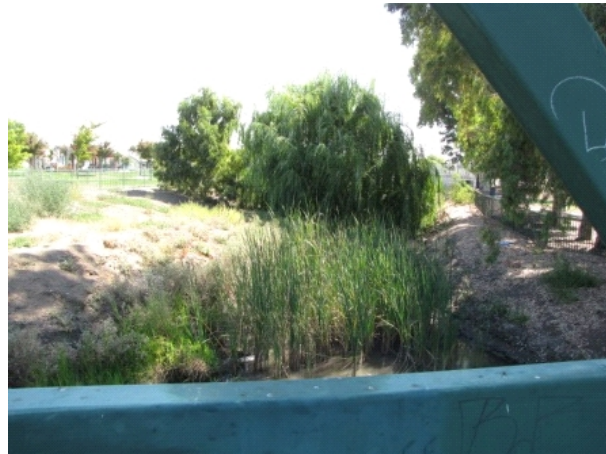
Levee Mile Report Line	56
Start Levee Mile	
End Levee Mile	
Location	
Category	Channels
Item	Vegetation & Obstructions
View looking upstream from the Pock Lane bridge.	
dpesaven_c_20100825_047.jpg

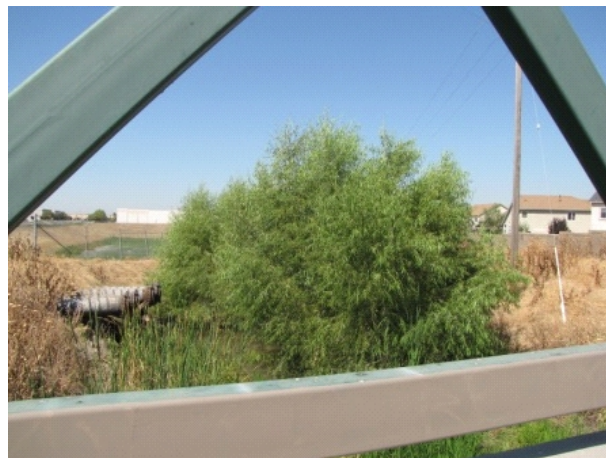
Levee Mile Report Line	61
Start Levee Mile	
End Levee Mile	
Location	
Category	Channels
Item	Vegetation & Obstructions
View looking downstream from the Pock Lane bridge.	
dpesaven_c_20100825_048.jpg

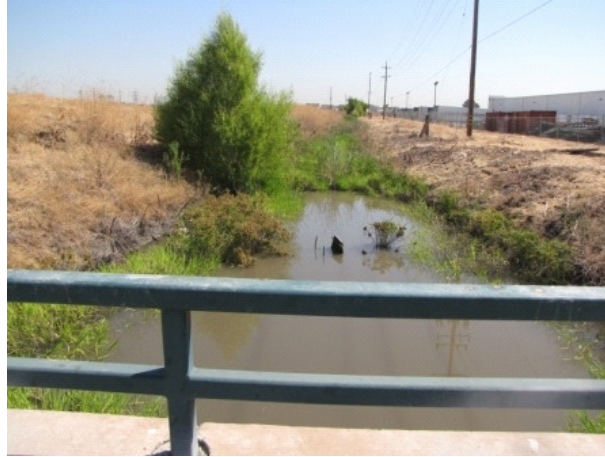
Levee Mile Report Line	66
Start Levee Mile	
End Levee Mile	
Location	
Category	Channels
Item	Vegetation & Obstructions
View looking upstream from the South B Street bridge.	
dpesaven_c_20100825_049.jpg

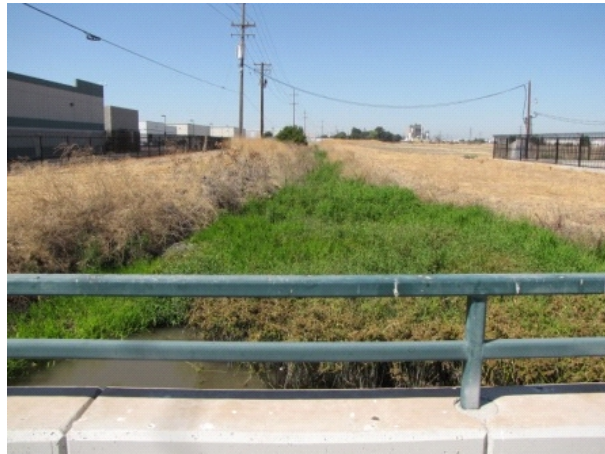
Levee Mile Report Line	71
Start Levee Mile	
End Levee Mile	
Location	
Category	Channels
Item	Vegetation & Obstructions
View looking downstream from the South B Street bridge.	
dpesaven_c_20100825_050.jpg

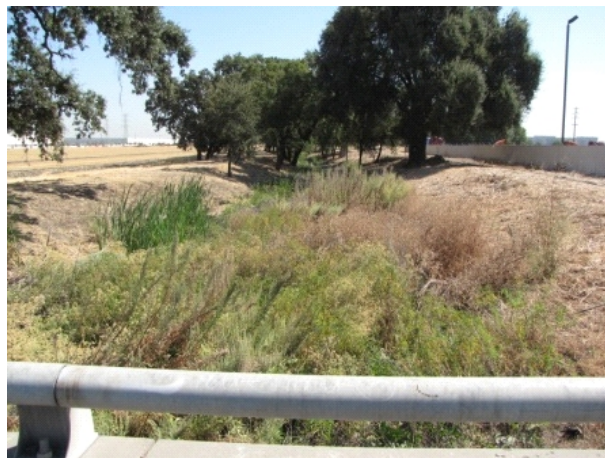
Levee Mile Report Line	76
Start Levee Mile	
End Levee Mile	
Location	
Category	Channels
Item	Vegetation & Obstructions
View looking upstream from the Airport Way bridge.	
dpesaven_c_20100825_051.jpg

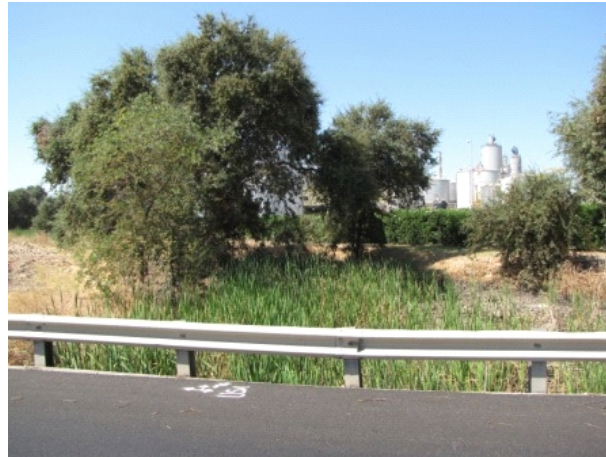
Levee Mile Report Line	81
Start Levee Mile	
End Levee Mile	
Location	
Category	Channels
Item	Vegetation & Obstructions
View looking downstream from the Airport Way bridge.	
dpesaven_c_20100825_052.jpg

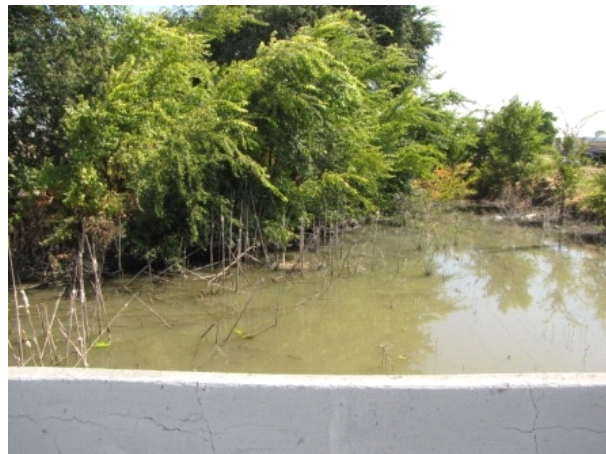
Levee Mile Report Line	86
Start Levee Mile	
End Levee Mile	
Location	
Category	Channels
Item	Vegetation & Obstructions
View looking upstream from the Producers Drive bridge.	
dpesaven_c_20100825_053.jpg

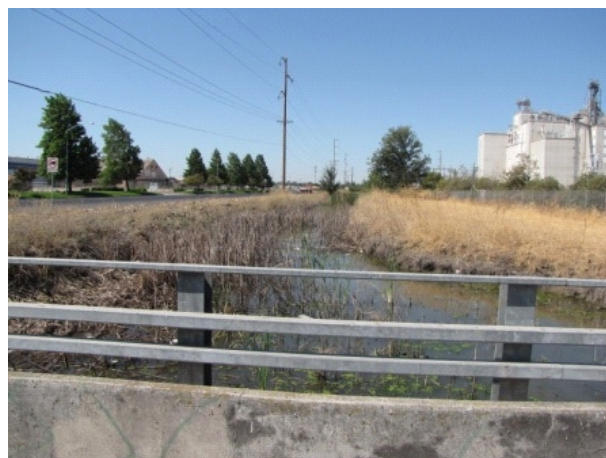
Levee Mile Report Line	91
Start Levee Mile	
End Levee Mile	
Location	
Category	Channels
Item	Vegetation & Obstructions
View looking downstream from the Producers Drive bridge.	
dpesaven_c_20100825_054.jpg

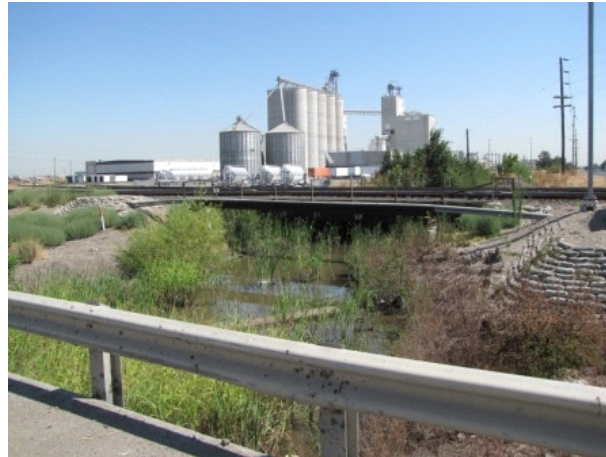
Levee Mile Report Line	96
Start Levee Mile	
End Levee Mile	
Location	
Category	Channels
Item	Vegetation & Obstructions
View looking upstream from the McKinley Avenue bridge.	
dpesaven_c_20100825_055.jpg

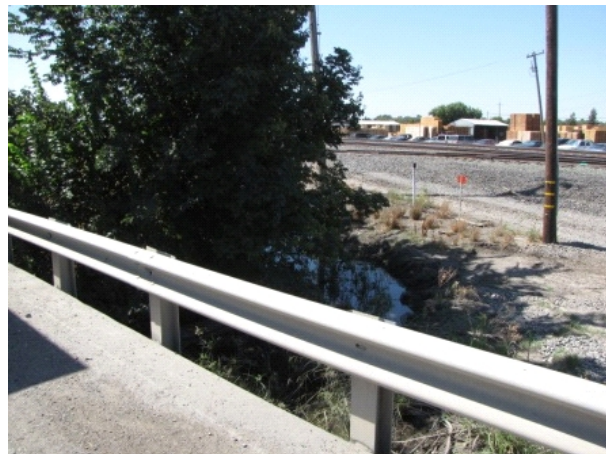
Levee Mile Report Line	101
Start Levee Mile	
End Levee Mile	
Location	
Category	Channels
Item	Vegetation & Obstructions
View looking downstream from the McKinley Avenue bridge.	
dpesaven_c_20100825_056.jpg

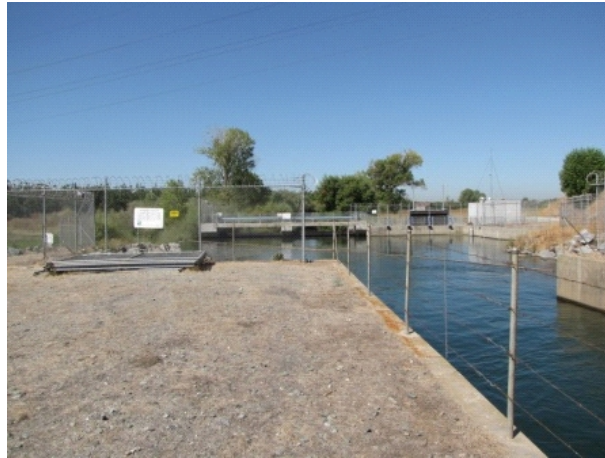
Levee Mile Report Line	1
Start Levee Mile	0.00
End Levee Mile	0.00
Location	
Category	Channels
Item	Vegetation & Obstructions
Looking downstream at the irrigation diversion structure at Farmington Dam at the northern portion of the channel.	
dpesaven_c_20100824_001.jpg

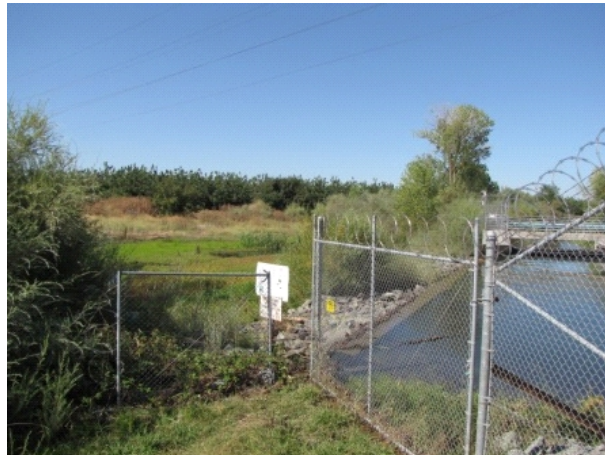
Levee Mile Report Line	1
Start Levee Mile	0.00
End Levee Mile	0.00
Location	
Category	Channels
Item	Vegetation & Obstructions
Looking downstream from the irrigation structure at the Farmington Dam at the northern portion of the channel.	
dpesaven_c_20100824_002.jpg

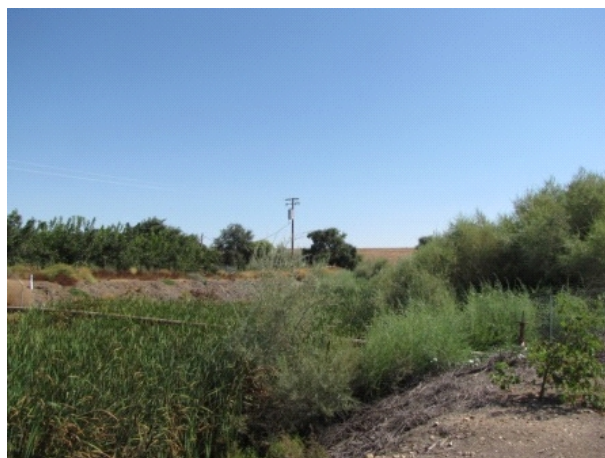
Levee Mile Report Line	1
Start Levee Mile	0.00
End Levee Mile	0.00
Location	
Category	Channels
Item	Vegetation & Obstructions
Looking upstream toward Farmington Dam on the southern portion of the channel.	
dpesaven_c_20100824_003.jpg

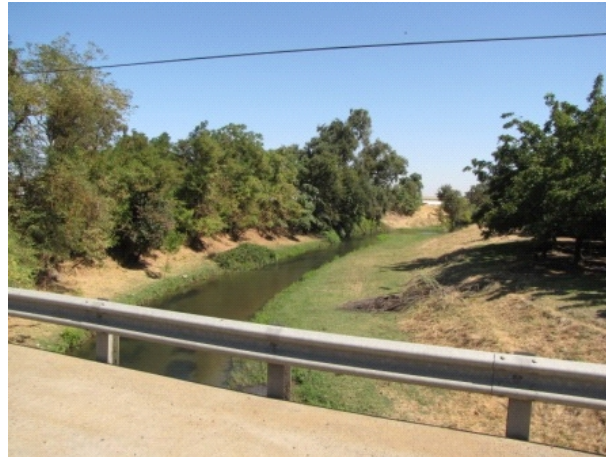
Levee Mile Report Line	6
Start Levee Mile	0.00
End Levee Mile	0.00
Location	
Category	Channels
Item	Vegetation & Obstructions
View looking upstream from the Sonora Road bridge.	
dpesaven_c_20100824_004.jpg

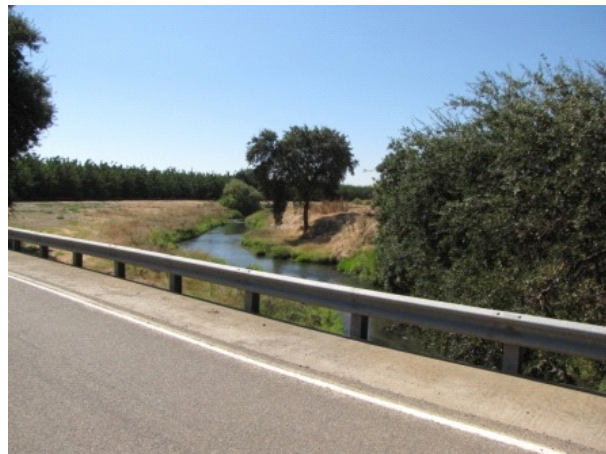
Levee Mile Report Line	11
Start Levee Mile	0.00
End Levee Mile	0.00
Location	
Category	Channels
Item	Vegetation & Obstructions
View looking downstream from the Sonora Road bridge.	
dpesaven_c_20100824_005.jpg

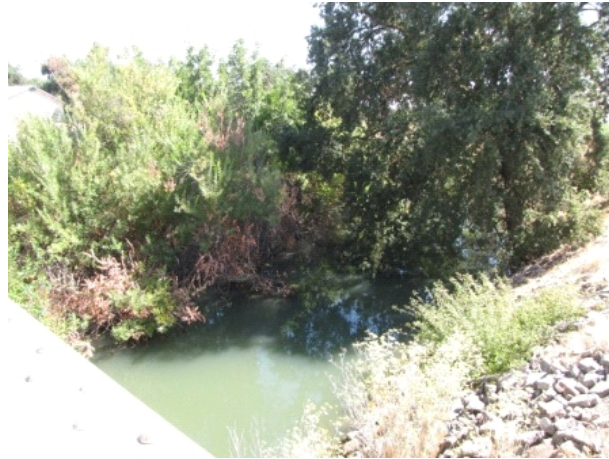
Levee Mile Report Line	16
Start Levee Mile	0.00
End Levee Mile	0.00
Location	
Category	Channels
Item	Vegetation & Obstructions
View looking upstream from the Escalon Bellota Road Bridge.	
dpesaven_c_20100824_006.jpg

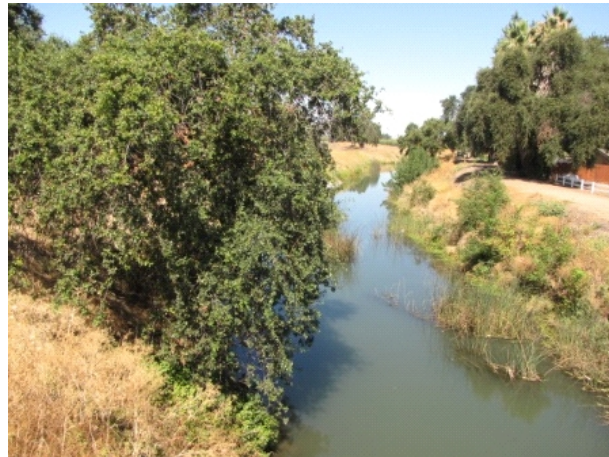
Levee Mile Report Line	21
Start Levee Mile	0.00
End Levee Mile	0.00
Location	
Category	Channels
Item	Vegetation & Obstructions
View looking downstream from the Escalon Bellota Road bridge.	
dpesaven_c_20100824_008.jpg

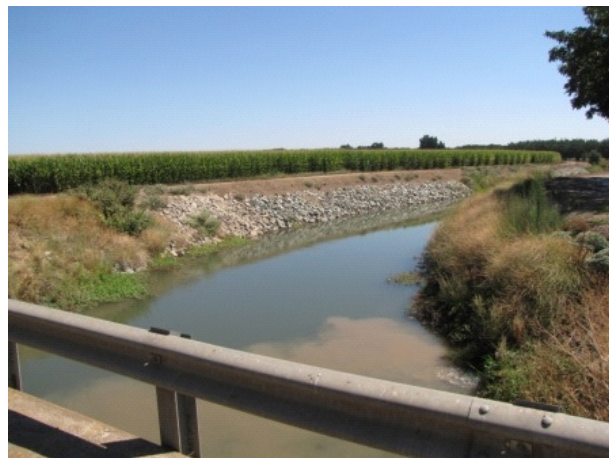
Levee Mile Report Line	26
Start Levee Mile	0.00
End Levee Mile	0.00
Location	
Category	Channels
Item	Vegetation & Obstructions
View looking upstream from the Stanley Road bridge.	
dpesaven_c_20100824_009.jpg

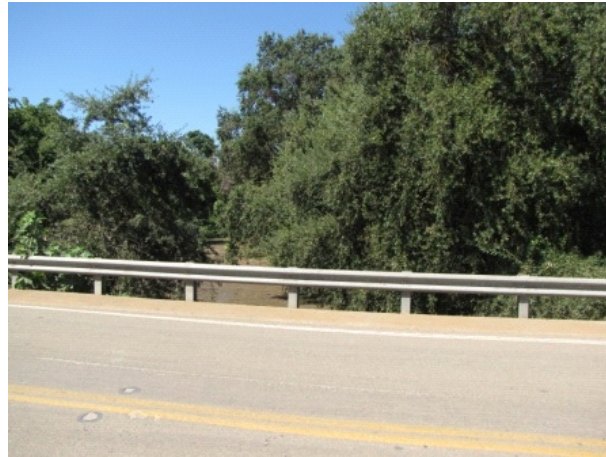
Levee Mile Report Line	31
Start Levee Mile	0.00
End Levee Mile	0.00
Location	
Category	Channels
Item	Vegetation & Obstructions
View looking downstream from the Stanley Road bridge.	
dpesaven_c_20100824_010.jpg

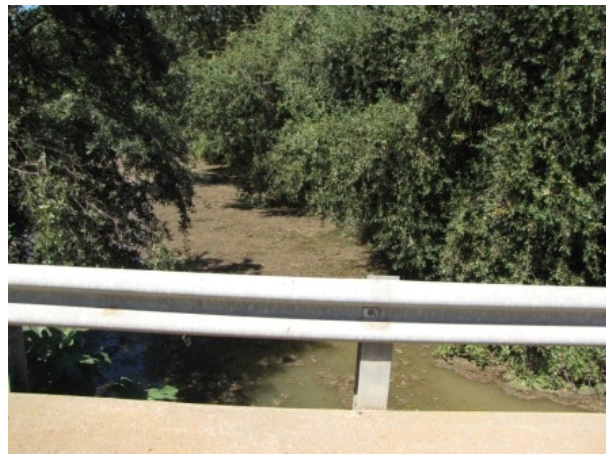
Levee Mile Report Line	31
Start Levee Mile	0.00
End Levee Mile	0.00
Location	
Category	Channels
Item	Vegetation & Obstructions
Additional view looking downstream from the Stanley Road bridge.	
dpesaven_c_20100824_011.jpg

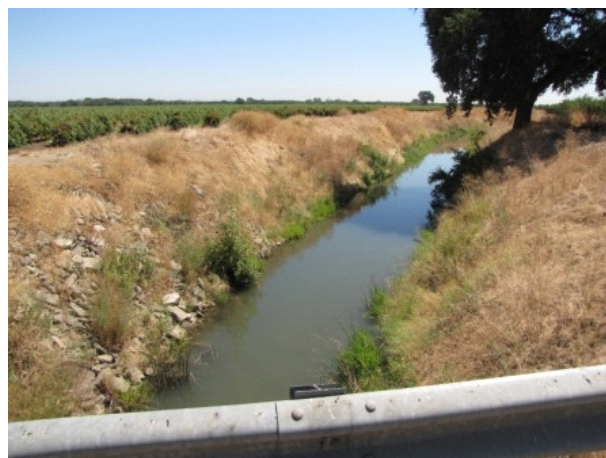
Levee Mile Report Line	36
Start Levee Mile	0.00
End Levee Mile	0.00
Location	
Category	Channels
Item	Vegetation & Obstructions
View looking upstream from the Van Allen Road bridge.	
dpesaven_c_20100824_021.jpg

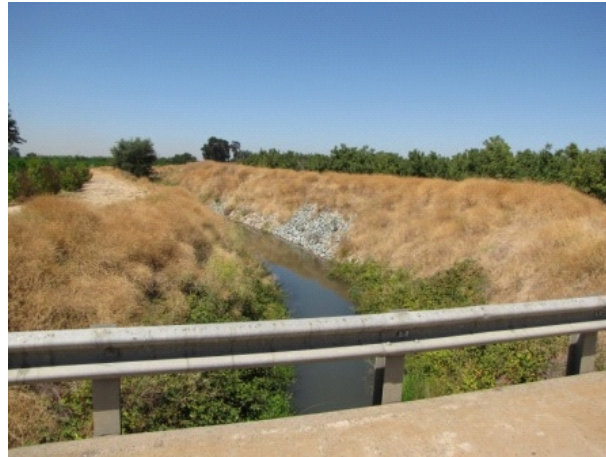
Levee Mile Report Line	41
Start Levee Mile	0.00
End Levee Mile	0.00
Location	
Category	Channels
Item	Vegetation & Obstructions
View looking downstream from the Van Allen Road bridge.	
dpesaven_c_20100824_022.jpg

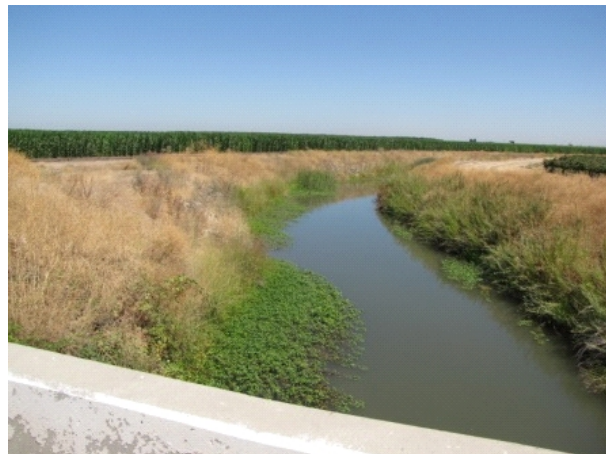
Levee Mile Report Line	46
Start Levee Mile	0.00
End Levee Mile	0.00
Location	
Category	Channels
Item	Vegetation & Obstructions
View looking upstream from the Mariposa Road bridge.	
dpesaven_c_20100824_023.jpg

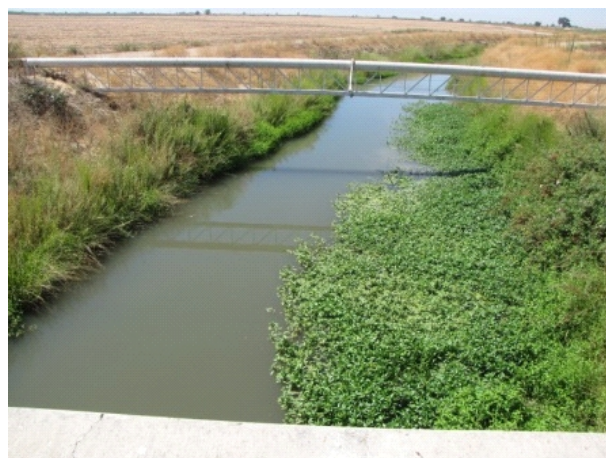
Levee Mile Report Line	51
Start Levee Mile	0.00
End Levee Mile	0.00
Location	
Category	Channels
Item	Vegetation & Obstructions
View looking downstream from the Mariposa Road Bridge.	
dpesaven_c_20100824_024.jpg

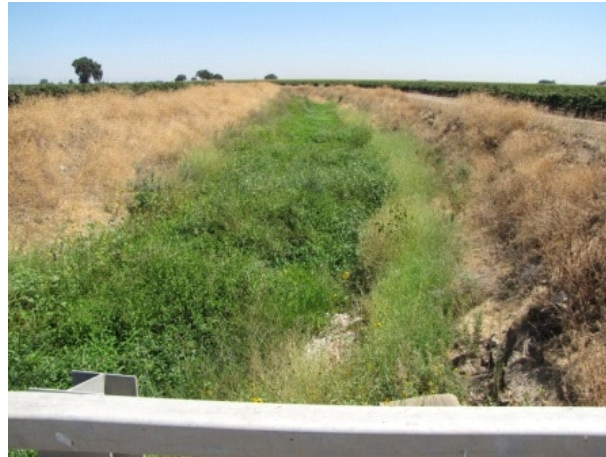
Levee Mile Report Line	56
Start Levee Mile	0.00
End Levee Mile	0.00
Location	
Category	Channels
Item	Vegetation & Obstructions
View looking upstream from the Jack Tone Road bridge.	
dpesaven_c_20100824_028.jpg

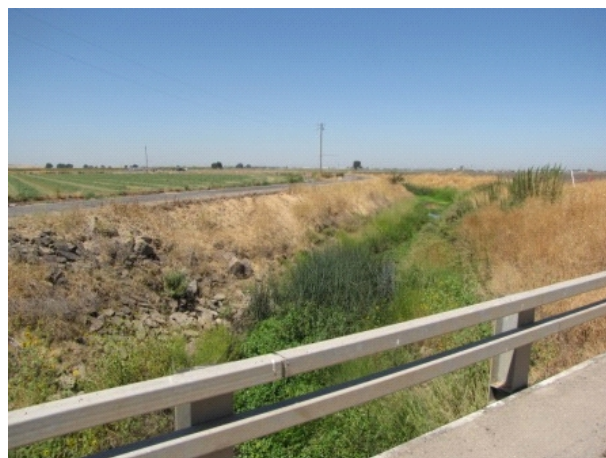
Levee Mile Report Line	61
Start Levee Mile	0.00
End Levee Mile	0.00
Location	
Category	Channels
Item	Vegetation & Obstructions
View looking downstream from the Jack Tone Road Bridge.	
dpesaven_c_20100824_029.jpg

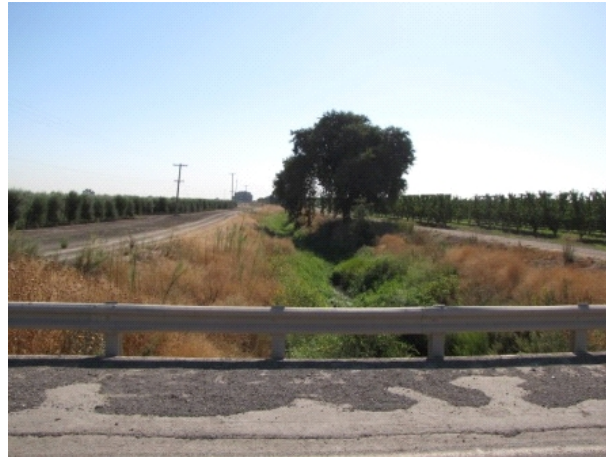
Levee Mile Report Line	66
Start Levee Mile	0.00
End Levee Mile	0.00
Location	
Category	Channels
Item	Vegetation & Obstructions
View looking upstream from the Austin Road bridge.	
dpesaven_c_20100825_042.jpg

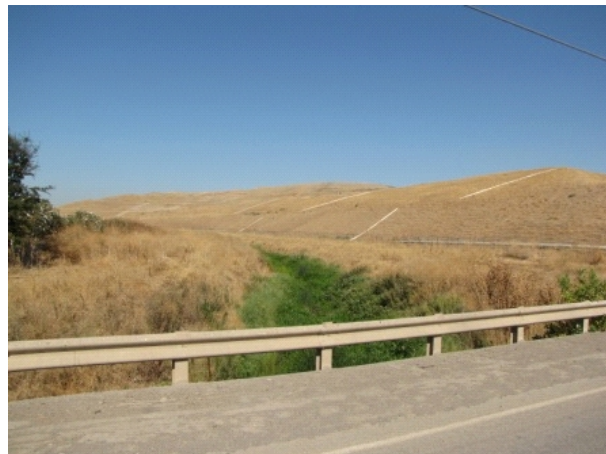
Levee Mile Report Line	71
Start Levee Mile	0.00
End Levee Mile	0.00
Location	
Category	Channels
Item	Vegetation & Obstructions
View looking downstream from the Austin Road bridge.	
dpesaven_c_20100825_043.jpg

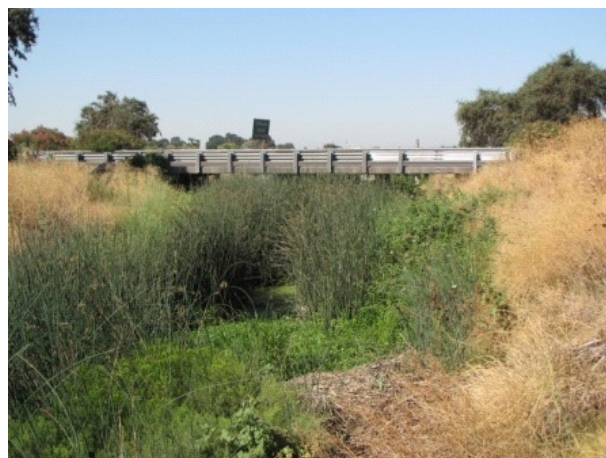
Levee Mile Report Line	76
Start Levee Mile	0.00
End Levee Mile	0.00
Location	
Category	Channels
Item	Vegetation & Obstructions
View looking downstream from the upstream side of the Highway 99 bridges.	
dpesaven_c_20100825_044.jpg

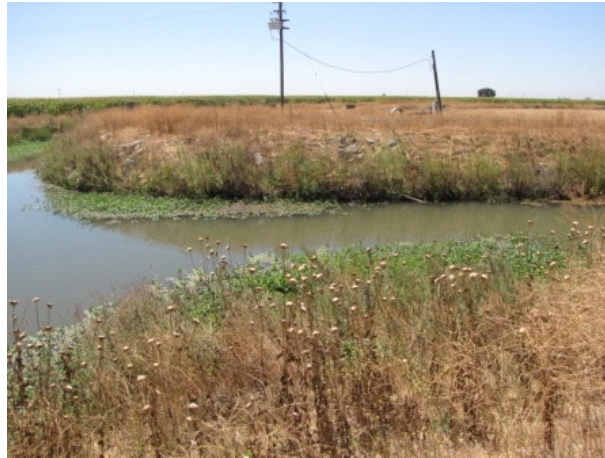
dpesaven\_c\_20100824\_025.jpg

View of the channel looking downstream along South Little John Creek where the North Branch splits.

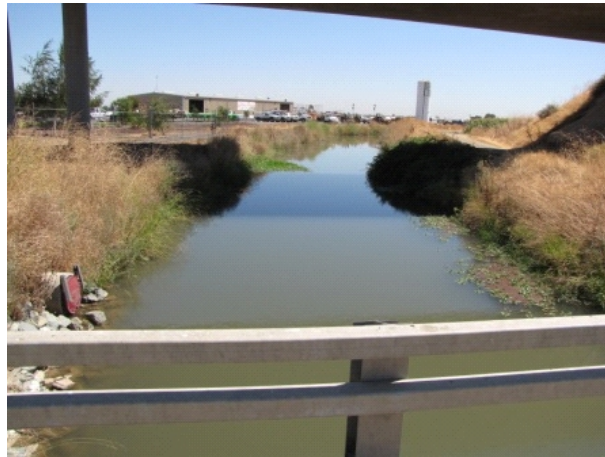
dpesaven\_c\_20100824\_026.jpg

View looking upstream from the old Jack Tone Road bridge.

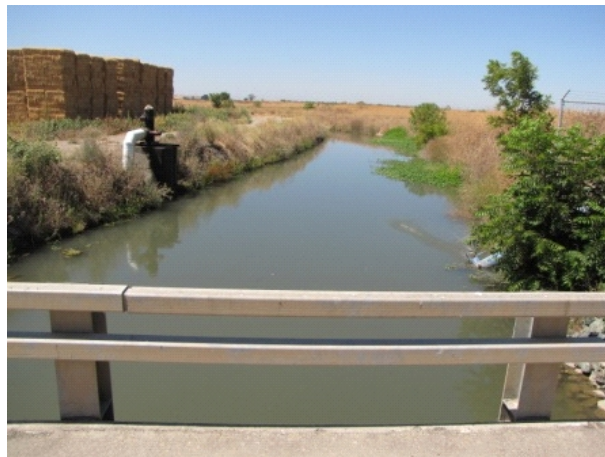
dpesaven\_c\_20100824\_027.jpg

View looking downstream from the old Jack Tone Road bridge.

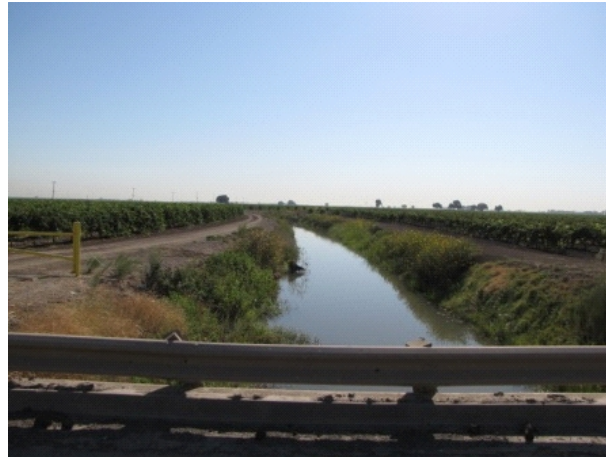
Levee Mile Report Line	16
Start Levee Mile	0.00
End Levee Mile	0.00
Location	
Category	Channels
Item	Vegetation & Obstructions
View looking upstream from the Austin Road bridge.	
dpesaven_c_20100825_039.jpg

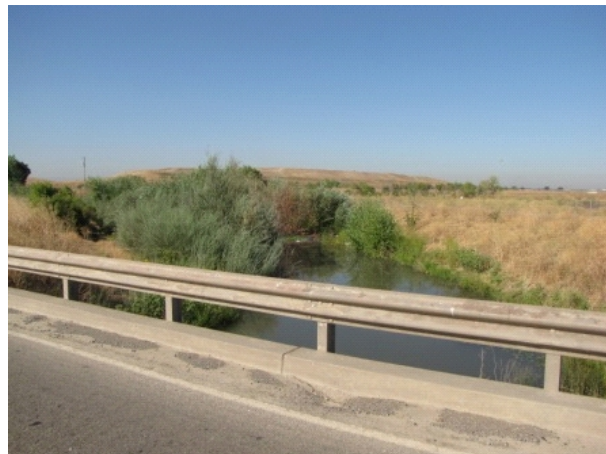
Levee Mile Report Line	21
Start Levee Mile	0.00
End Levee Mile	0.00
Location	
Category	Channels
Item	Vegetation & Obstructions
View looking downstream from the Austin Road bridge.	
dpesaven_c_20100825_040.jpg

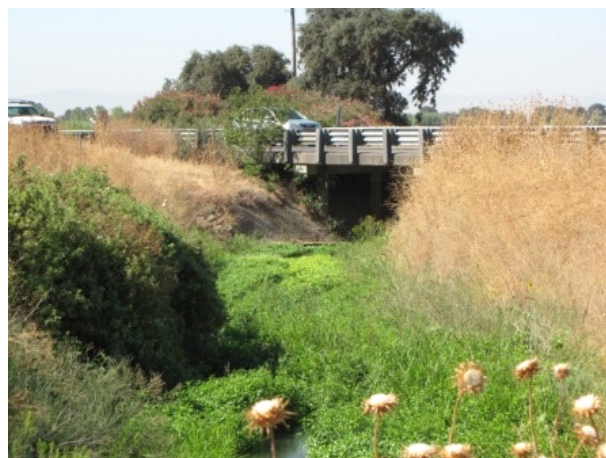
Levee Mile Report Line	26
Start Levee Mile	0.00
End Levee Mile	0.00
Location	
Category	Channels
Item	Vegetation & Obstructions
View looking downstream at the upstream side of the Highway 99 bridges.	
dpesaven_c_20100825_041.jpg
